Annual Report No. 11

January 1, 2022, to December 31, 2022
Civil Action No. 1:10cv4039 - SDG

DeKalb County
Department of Watershed Management

March 1, 2023

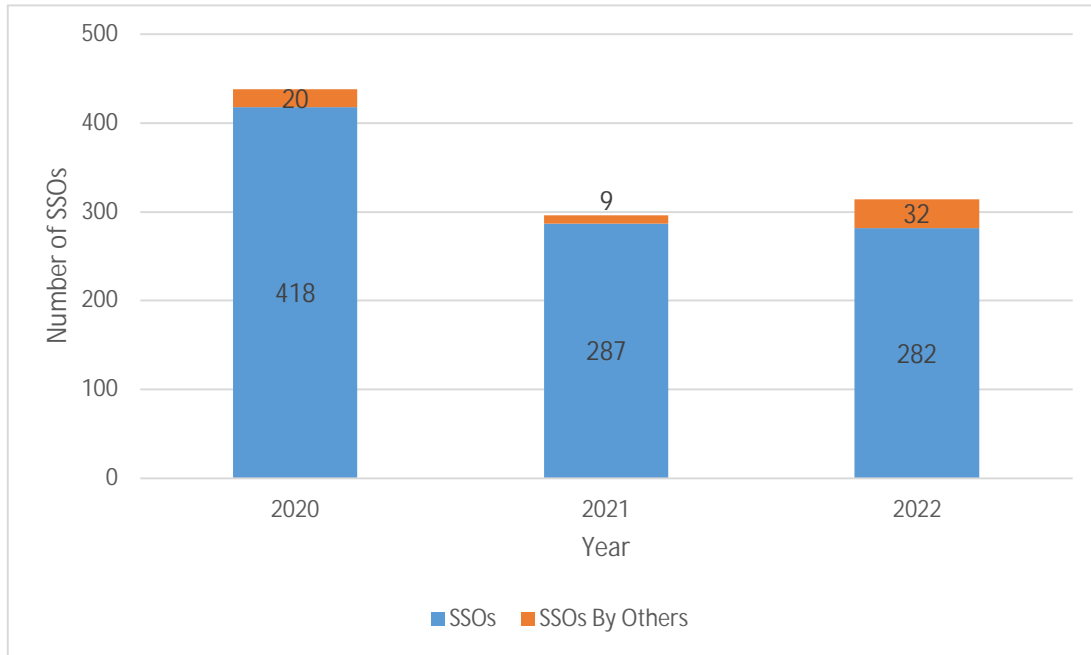
Figure ES-1 Reported SSOs per Year (2020–2022)

Overall, the number of SSOs per year has decreased by 39 percent since the CD was lodged in 2012. For maintenance-related SSOs, this is largely attributable to the County’s MMS program including sewer cleaning, the FOG program, and extensive public education campaigns. Figure ES-1 shows the number of SSOs from 2020 to 2022. The higher number of SSOs in 2020 corresponds to the higher than normal annual rainfall comprised of multiple wet weather events greater than a 2 year recurrence. 2021 and 2022 were closer in annual rainfall, but the total SSOs in 2022 is higher than in 2021 when including SSOs by Others. When SSOs by Others are excluded, the number of SSOs within the County remain similar from 2021 to 2022.

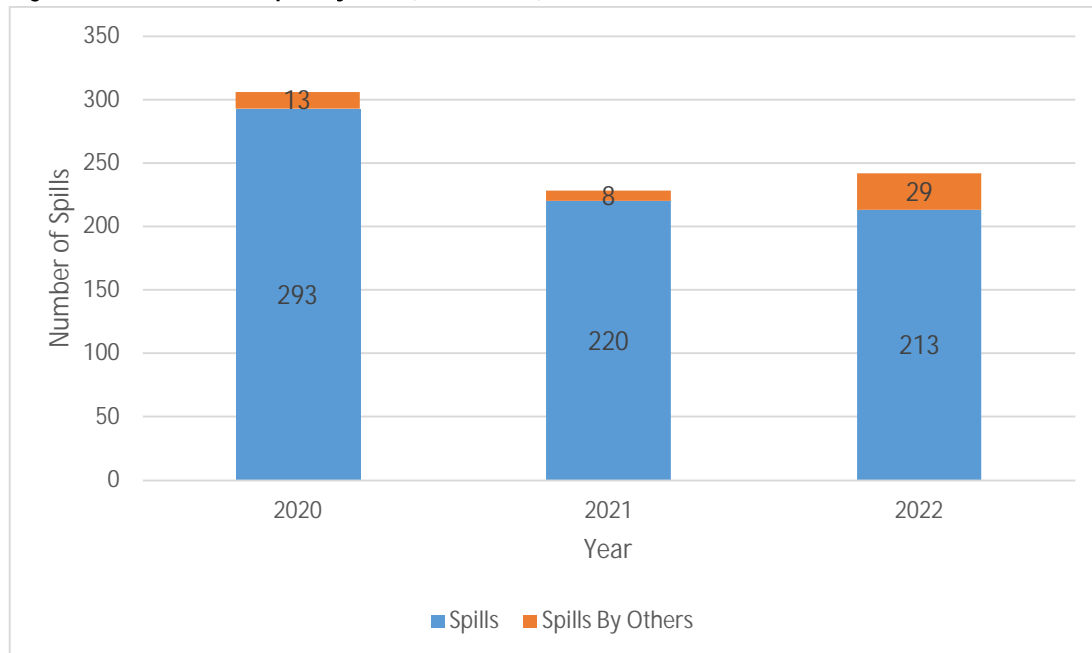
Figure ES-2 Total Spills by Year (2020–2022)

Figure ES-2 shows the number of spills, or discharges of wastewater, that reach waters of the United States or the State. The number of spills increased from 228 in 2021 to 242 in 2022. Of the 242 spills reported in 2022, 29 occurred at two sites due to backwater from a sewer main not owned by the County. Excluding these spills, a total of 213 spills occurred in 2022, a decrease from 2021.

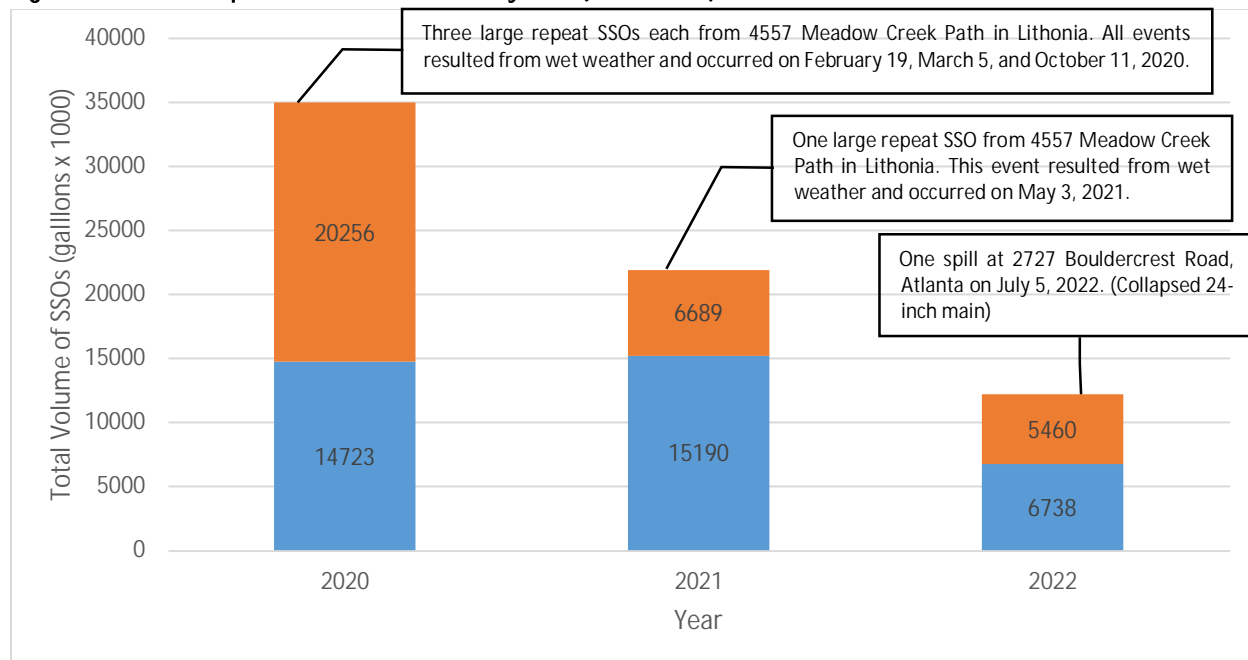
Figure ES-3 **Reported Volumes of SSOs by Year (2020–2022)**

Figure ES-3 shows the total annual reported SSO volumes for 2020 through 2022. There has been a steady decrease in overall volume since 2020, particularly in 2022. The largest contributors to spill volume are structural SSOs involving breaks on large diameter sewer trunks and wet weather caused SSOs. The County had a sewer main break outside the PASARP that resulted in an SSO of more than 5

million gallons, but some of the repeat wet weather SSOs, while they continued to occur, experienced a decrease in volume.

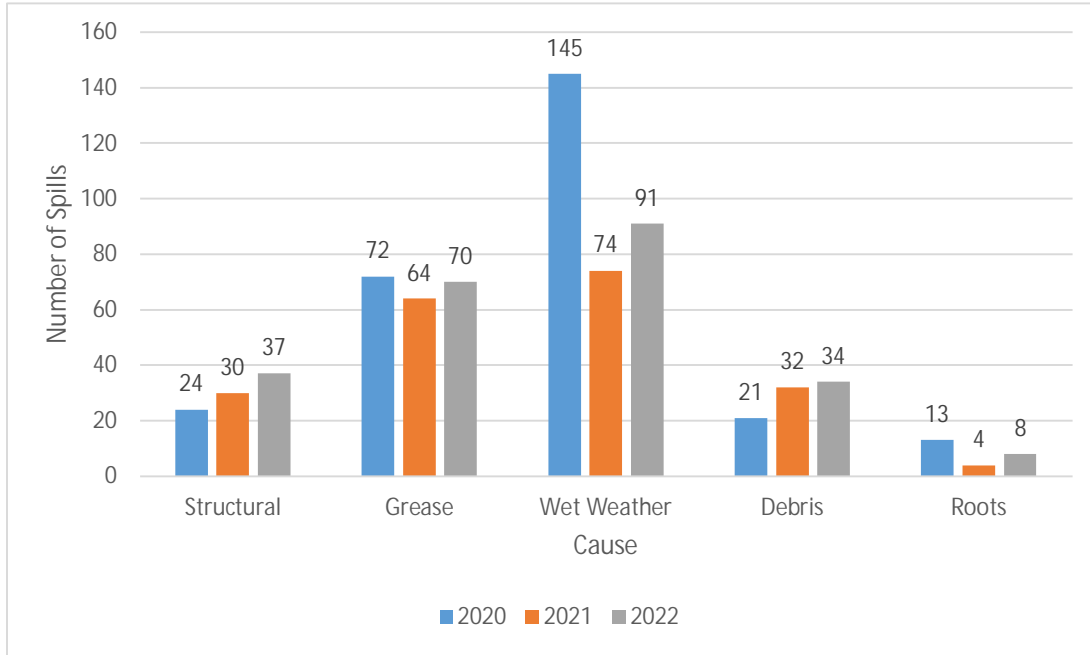
Figure ES-4 Total Spills by Year by Cause Category (2020–2022)

As shown on Figure ES-4, the number of spills attributable to structural causes increased from 2021 to 2022. Spills attributable to grease increased slightly by 10 percent from 2021 to 2022. The number of spills attributable to wet weather increased in 2022 compared to 2021 by 23 percent, but when spills by others were removed, the number of spills attributed to wet weather remained constant from 2021 to 2022. Spills attributable to debris increased slightly by 6 percent in 2022 from 2021. Spills attributable to roots increased by 50 percent in 2022 from 2021 but remained 38 percent below 2020 levels.

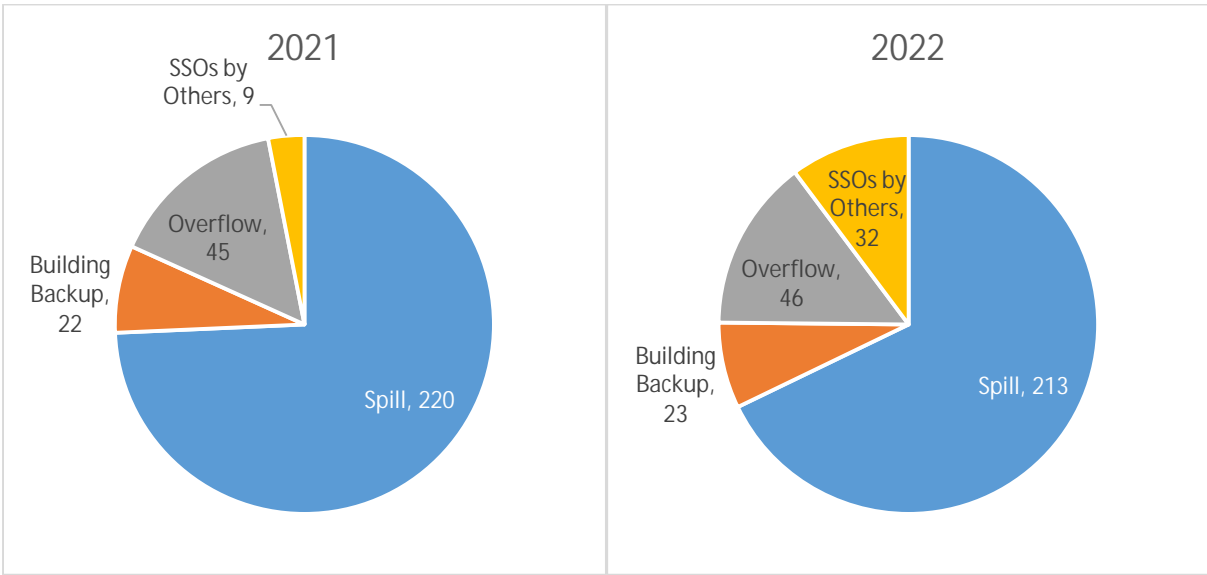
Figure 1-1 SSOs by Type (2021–2022)

Figure 1-1 shows the distribution of SSOs by type for 2022 as compared to 2021. Spills account for the majority of the SSOs followed by overflows then building backups. Beginning in the 3rd Quarter 2022 Report, the County begin to report SSOs by Others separately. SSOs by Others are SSOs that occur from County laterals, but the root cause is attributed to sewer mains owned and maintained by other utilities. A review of SSOs with root causes within the County-maintained system shows building backups and overflows remaining consistent and a slight decrease in spills from 2021 to 2022.

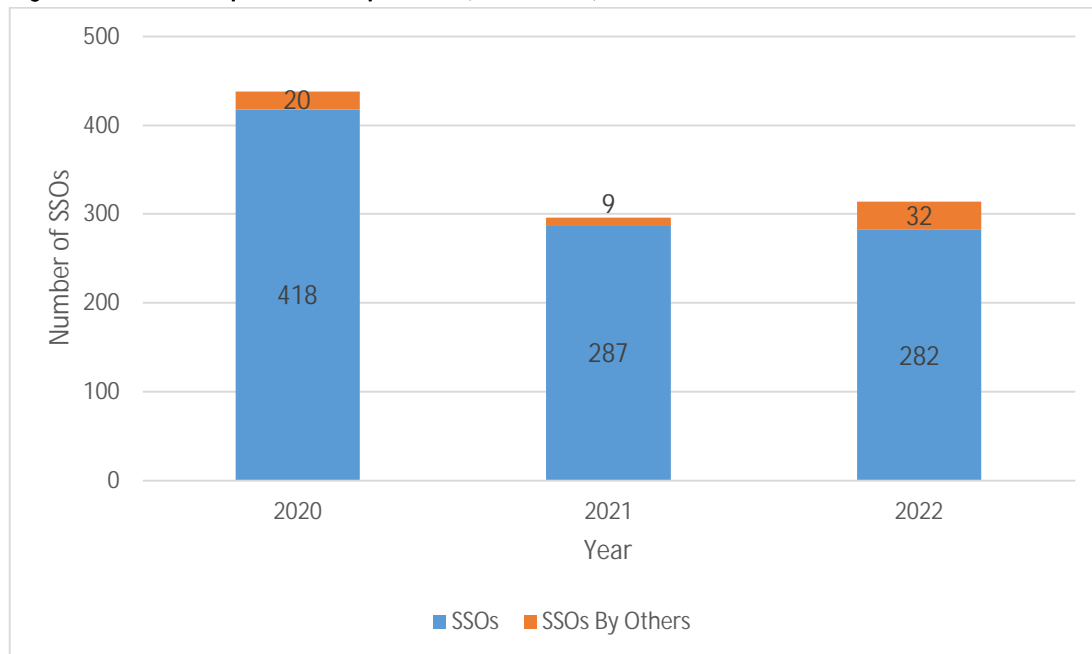
Figure 2-1 Reported SSOs per Year (2020–2022)

As shown on Figure 2-1, the number of SSOs per year decreased from 2020 to 2021, which can be partially attributed to a decrease in extreme wet weather events. The number of SSOs increased by 6% from 2021 to 2022, but when SSOs by Others are separated, the increase in total SSOs is attributed to an increase in SSOs that occurred from County laterals due to capacity limitations within a City of Atlanta trunk sewer. Overall, the number of SSOs decreased by 39 percent since the CD was lodged in 2012. The overall decreasing trend in the number of SSOs since 2012 can be attributed to the County's MMS programs including sewer cleaning, root control, the FOG program, and extensive public education campaigns. Several program improvements have allowed the County to more readily identify and respond to SSOs. These improvements include expansion of the County's flow monitoring network, further progress of sewer system investigation activities, new stream sampling protocols to detect spills, and implementation of the Cityworks work order management system to track identification and response to SSOs.

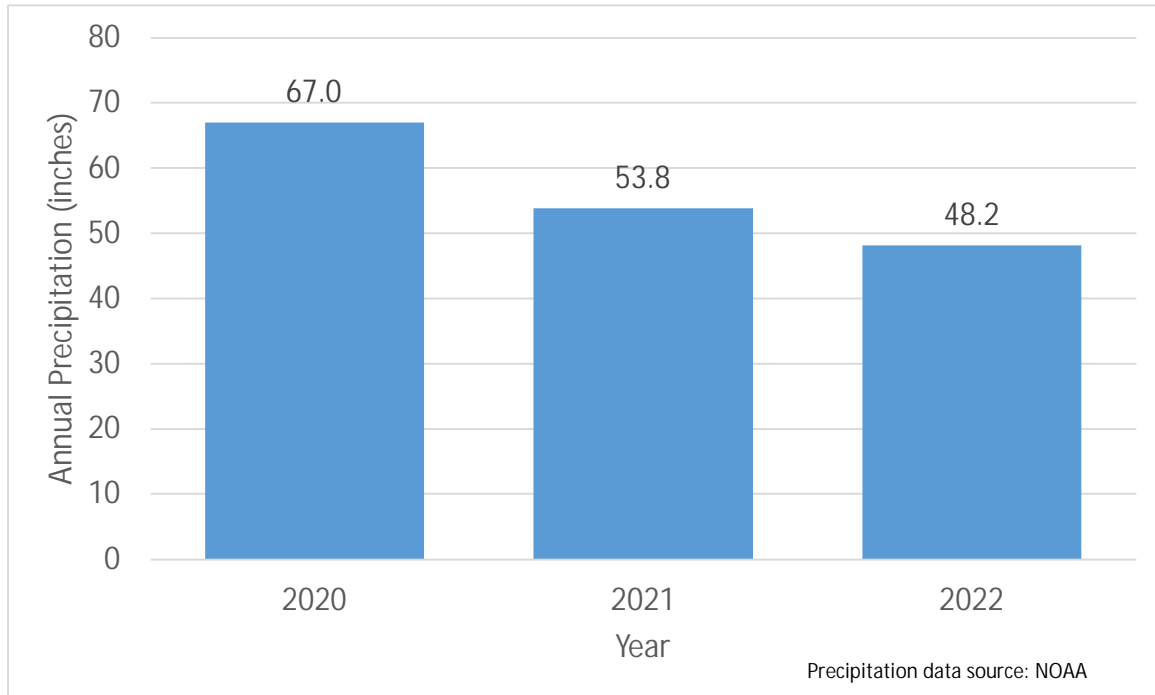
Figure 2-2 Annual Precipitation (inches) (2020–2022)

Figure 2-2 shows annual rainfall for the same period of record (2020–2022). Total rainfall for the year decreased from 2020 to 2022. The total rainfall recorded in 2022 was approximately 6 inches less than 2021 but there were still wet weather events greater than a 2-year recurrence level, as well as periods of constant lower rainfall intensities that increased infiltration within the WCTS.

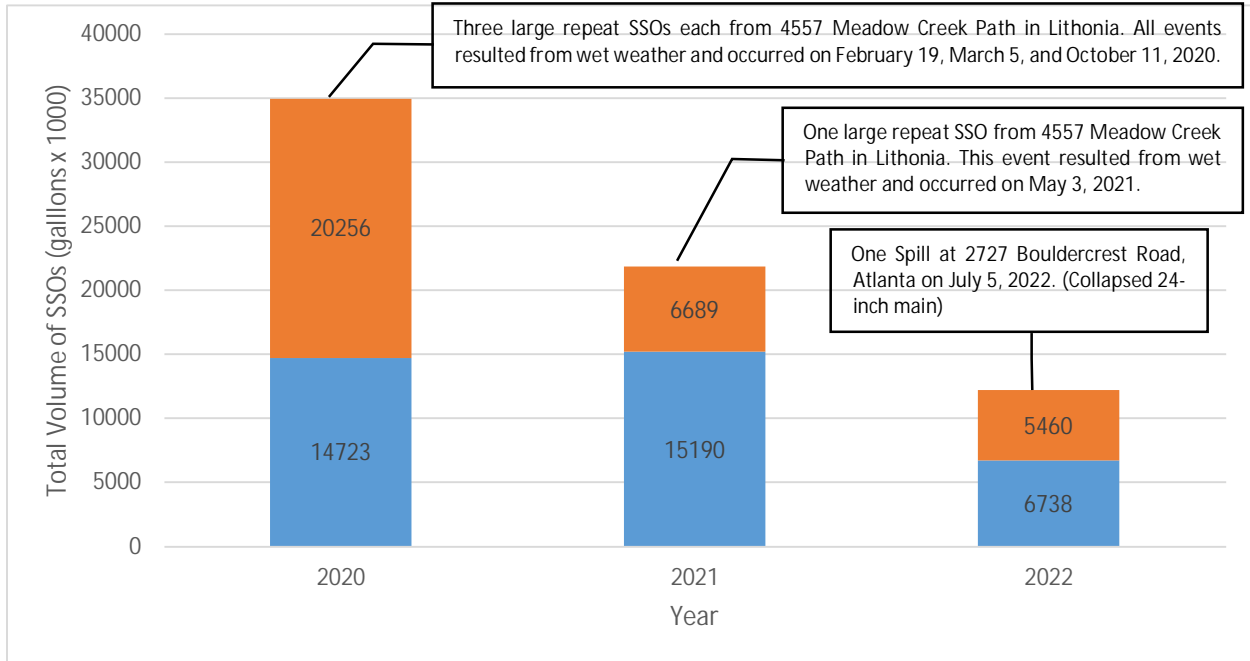
Figure 2-3 Reported Volume of SSOs per Year (2020–2022)

Figure 2-3 presents the total volume (gallons) of SSOs for 2020–2022. Prior to 2019 and until 2020, an overall trend in decreasing volume was observed, especially when considering outliers. However, the major storm events of 2020 resulted in a significant increase in SSO volumes, with the three largest outliers all occurring at repeat SSO site, Meadow Creek Path. The trend is back on a downward trajectory this year, though one outlier was recorded, which was attributed to a broken 24-inch main associated with 2727 Bouldercrest Road, Atlanta. The high volume was due not only to the size of the main but the spill was detected from stream sampling efforts. Once the laboratory results returned elevated fecal counts, DWM walked the stream from the sampling point upstream until the broken pipe, which failed due to streambank erosion, was located. The volume reflects the time required not only to repair the failure but to locate it. The repairs associated with 2727 Bouldercrest involved the installation of 62 LF of 24-inch DIP pipe and was completed on August 4, 2022. While cleaning and FOG program enforcement have decreased maintenance-related SSOs overall, wet-weather-related SSOs are expected to decrease as the County begins construction on large-capacity projects.

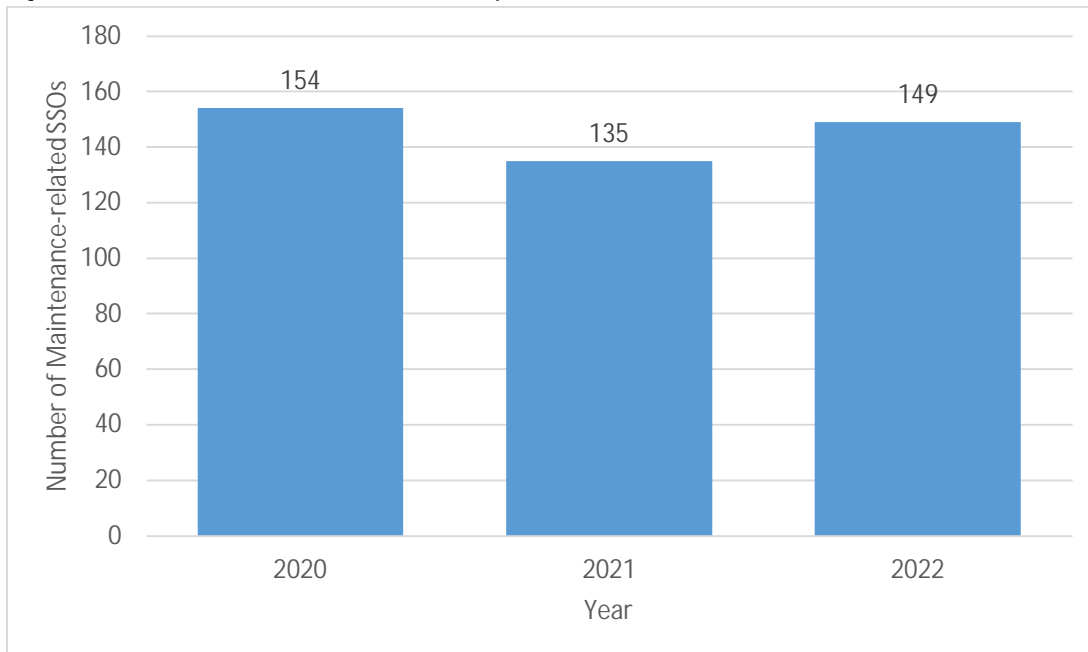
Figure 2-4 Maintenance-Related SSOs per Year (2020–2022)

Figures 2-4 and 2-5 show the number of maintenance-related SSOs and the associated annual volumes, respectively, from 2020 through 2022. From a peak of 265 SSOs in 2013 to 149 SSOs in 2022, DWM has reduced maintenance-related SSOs by 44 percent through a steady downward trend. The increase in SSOs from 2021 to 2022 is due to an update in reporting. In 2022, the County began to review the details of SSOs with a cause of unknown. If the work order comments indicate the SSO is due to an unknown blockage as opposed to an unknown cause altogether, it is now reported as a maintenance issue.

Note: Maintenance-related SSOs are caused by grease, roots, debris, or any combination thereof.

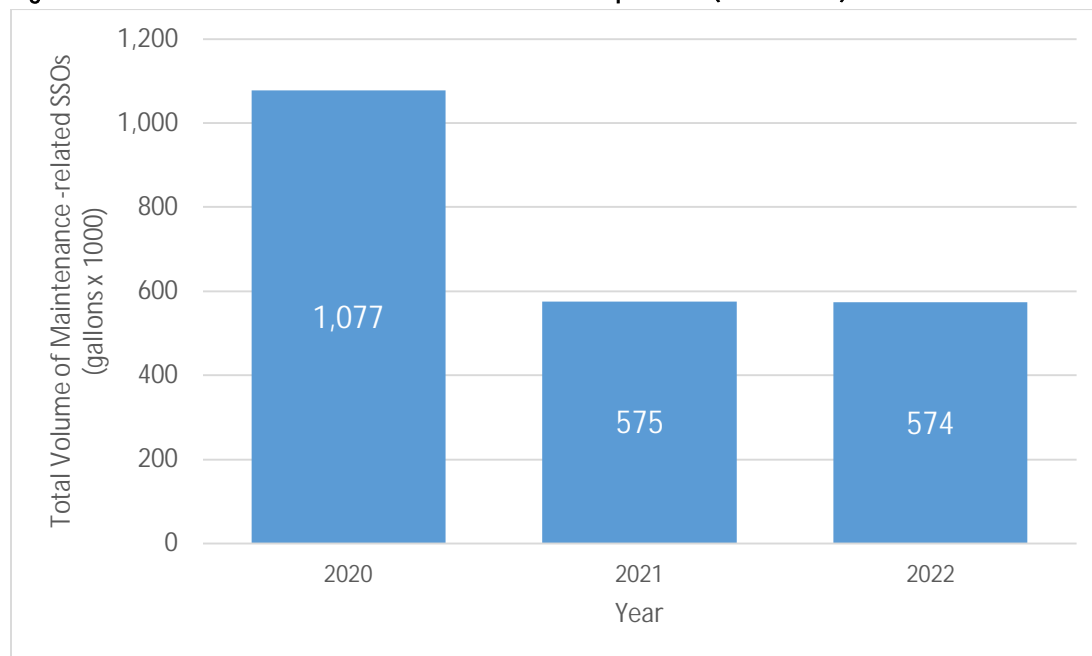
Figure 2-5 Volume of Maintenance-Related SSOs per Year (2020–2022)

The volume of maintenance-related SSOs for 2022 decreased significantly (about 47 percent) from 2020 and has remained constant since 2021. As discussed previously, DWM believes this is attributable to the County's implementation of MMS programs, such as sewer cleaning, root control, Cityworks, and the effectiveness of the FOG Management Program and public education campaigns.

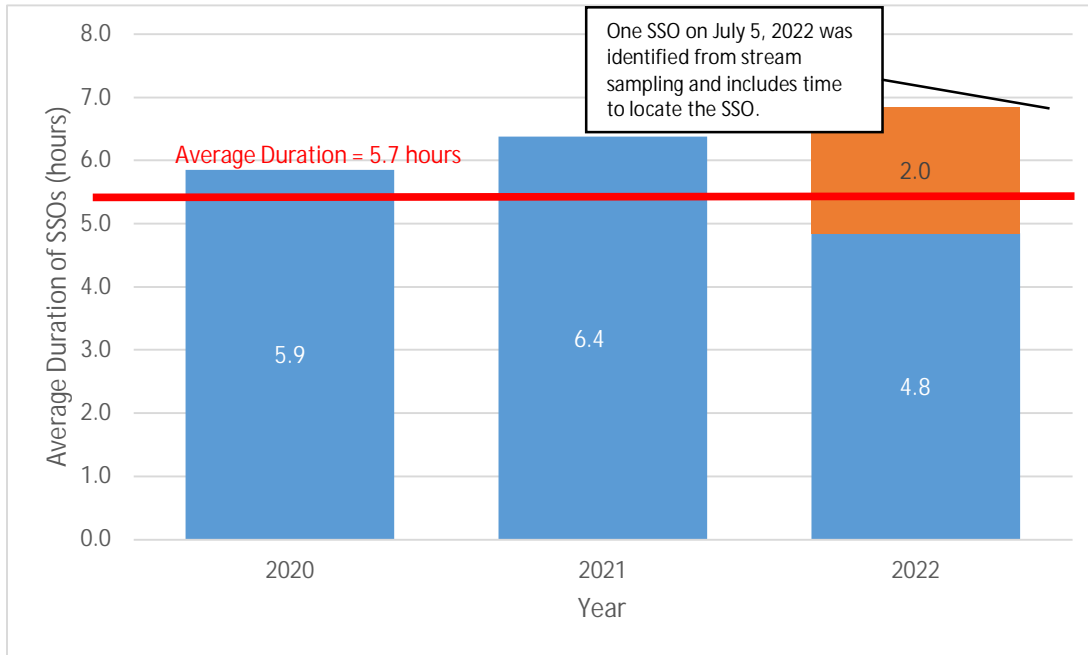
Figure 3-1 Average SSO Duration by Year (2019–2021)

Duration of SSOs are calculated from the time the SSO was reported until it is resolved. This parameter depends on how the SSO was identified, how quickly the source can be located and accessed, and the cause of the SSO. The average SSO duration from 2020 through 2022 was approximately 5.7 hours, when removing one SSO from July 5, 2022 as shown on Figure 3-1. On July 5, 2022, the County took samples from South River. Laboratory results from the samples indicated elevated fecal levels. Subsequently, County crews started at the location the samples were taken and walked upstream until the location of the spill was identified at Bouldercrest Rd. A sewer main collapsed due to streambank erosion causing the spill into the creek. The County was able to stop the spill and repair the main with the extended duration taking into account the time from sampling to repair of the break.

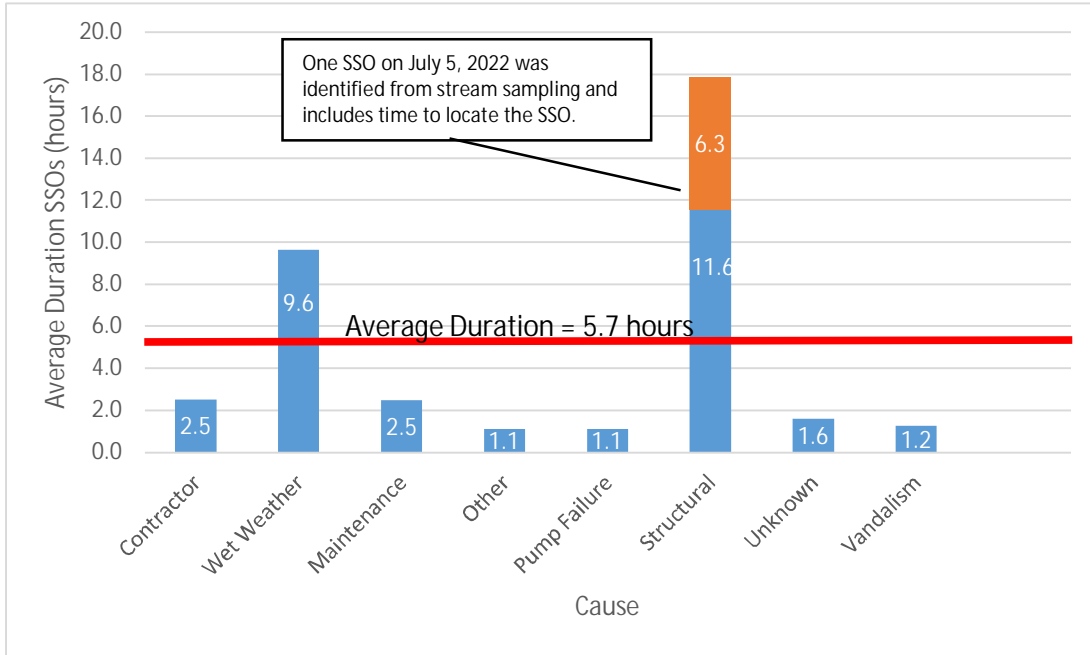
Figure 3-2 Average SSO Duration by Cause (2020–2022)

Figure 3-2 presents average durations for all SSOs from 2020 through 2022. Two causes had durations that were greater than average: wet weather and structural.

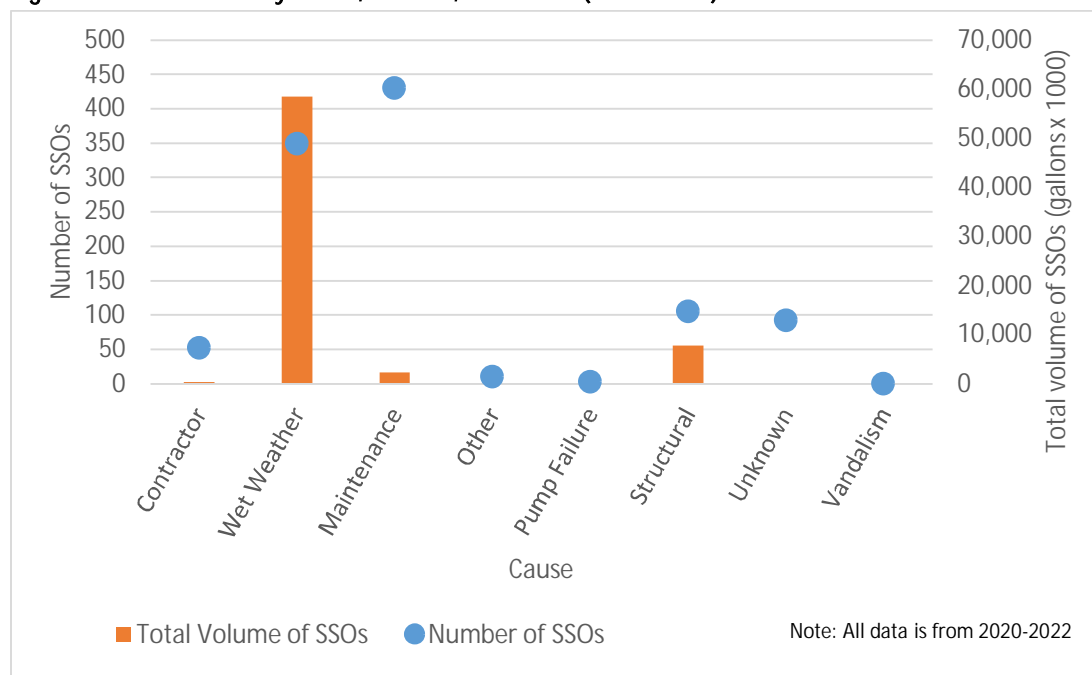
Figure 4-1 SSOs by Count, Volume, and Cause (2020–2022)

Maintenance-related SSOs, including grease, roots, and debris, decreased from 2012 to 2022 by 51 percent, a result, in part, of increased sewer cleaning and the County's commercial FOG Management Program and Public Education Programs. In reviewing data from the past 3 years, blockages continue to account for more SSOs than any other cause (42 percent) and represent the second greatest volume (5 percent) of all SSO causes (refer to Figure 4-1). The cause with the greatest volume is storms, and the County has taken steps to address impacts from storm-related events. Specifically, the County has undertaken follow-up and corrective action for private I/I and stormwater connections to the sanitary sewer in the Priority Areas. In 2022, 258 cleanout caps were replaced by DWM in the field. The continuation of these programs, along with the rehabilitation construction that is now underway, will begin to eliminate sources of I/I within the sewer system and provide additional capacity to help reduce the SSOs that occur because of wet weather.

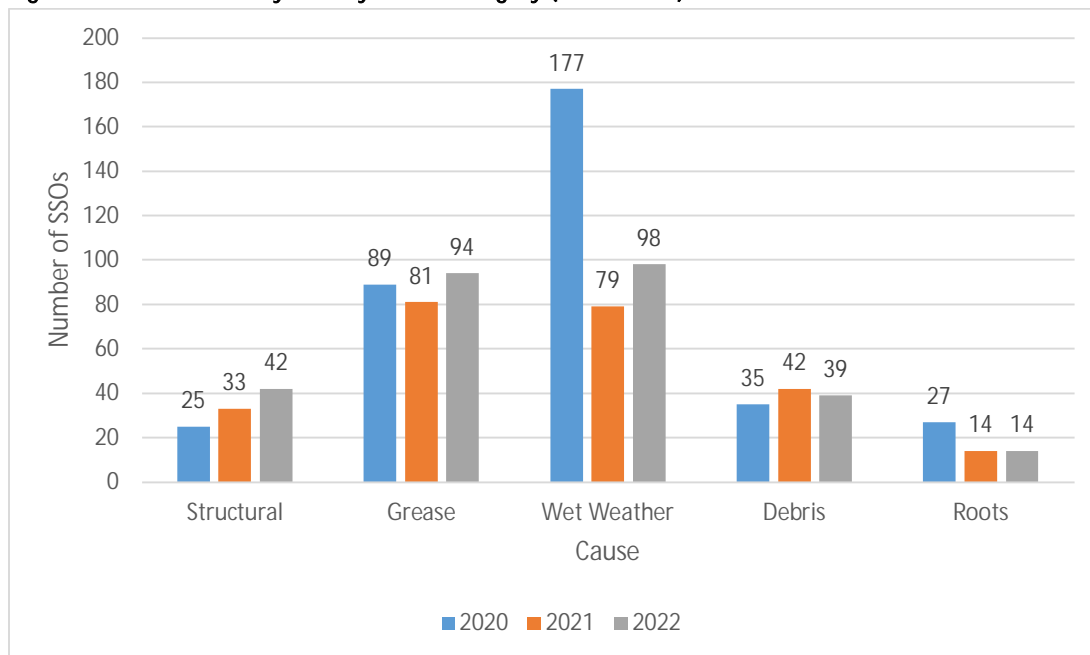
Figure 4-2 SSOs by Year by Cause Category (2020–2022)

Selected causes can be grouped into categories that help assess the effectiveness of DWM's efforts to reduce SSOs. These broader categories are grease, structural, wet weather, and debris. Table 4-1 lists the causes assigned to each category. As shown on Figure 4-2, there has been an increase in structural SSOs as well as grease but a decrease in debris SSOs compared to 2021 levels. The increase in grease-related SSOs can be attributed to increased restaurant activity as COVID-19 restrictions are easing, while the increase in structural SSOs is being seen outside the PASARP areas. Currently, the focus for sewer rehabilitation and replacement is within the PASARP areas; structural failures outside the PASARP can be attributed to aging infrastructure. The number of wet weather SSOs increased by 24 percent compared to 2021 levels, but the increase has been in the number of SSOs by Others.

Cause Categories may include more than one cause. Some SSOs appear in more than one Cause Category.

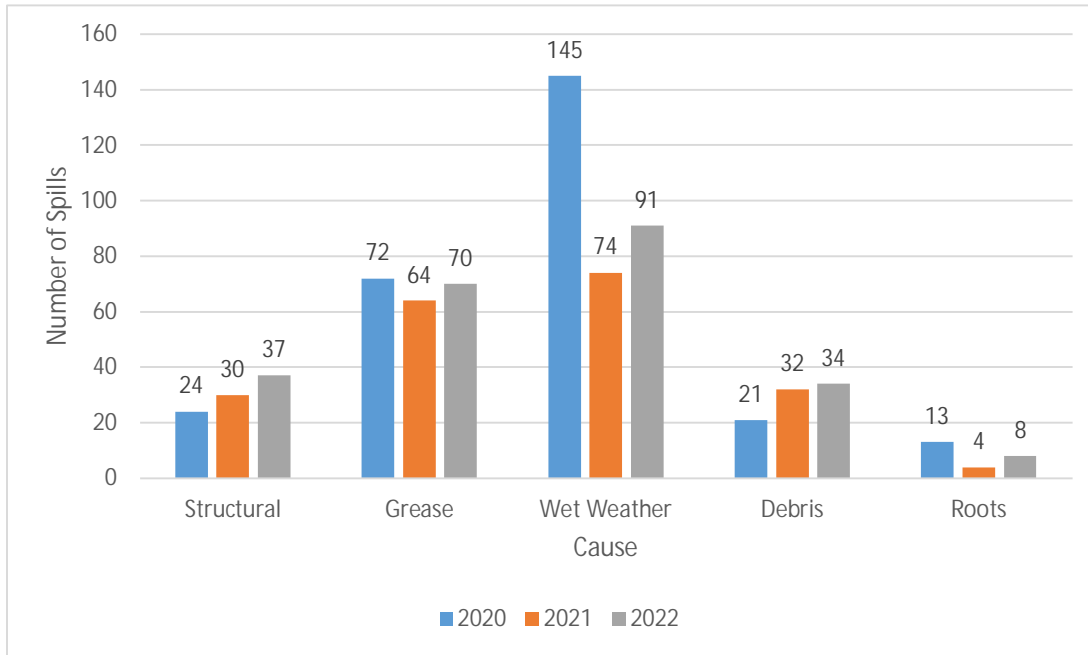
Figure 4-3 Spills by Year by Cause Category (2020–2022)

These same cause categories, when applied specifically to spills, show similar trends (refer to Figure 4-3).

Note: Cause Categories may include more than one cause. Some SSOs appear in more than one Cause Category. Other causes for spills not shown in this figure include pump failure, vandalism, contractor-related, etc.

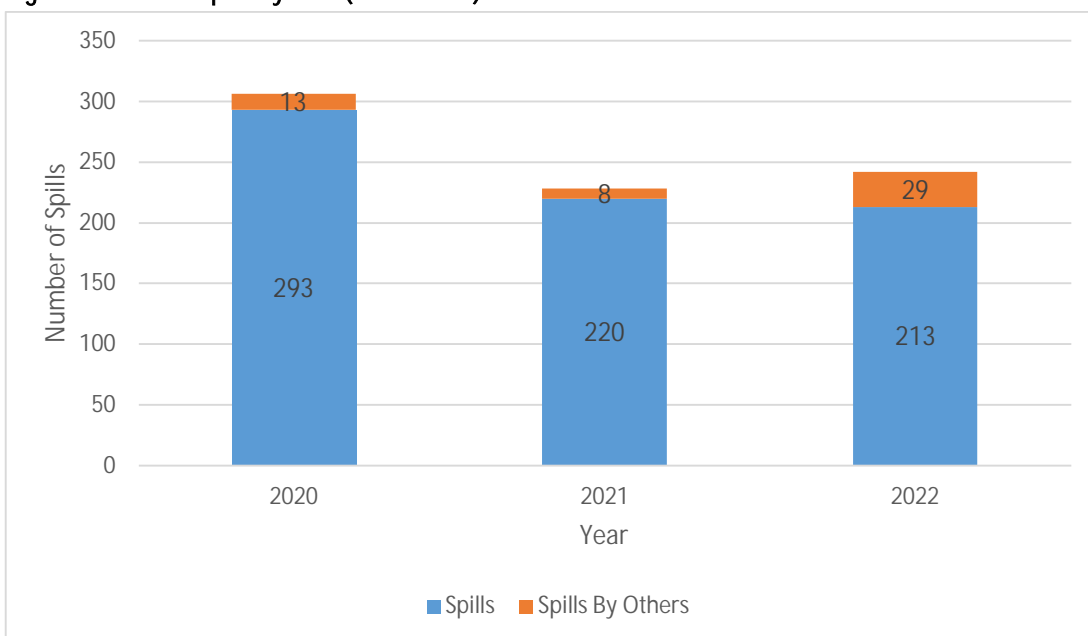
Figure 4-4 Spills by Year (2020–2022)

Figure 4-4 presents the number of spills by year. The number of total spills per year decreased from 2020 to 2021 but increased in 2022. This is heavily influenced by the number and type of rain events over the course of the year causing wet weather spills however the County has seen an increase in SSOs where the root cause has been on sewer mains owned and maintained by others. During 2020, construction completed at two historical SSO sites that previously experienced multiple spills per year. In 2022, there has been a continuation of pipe upsizing and rehabilitation construction to work to reduce SSOs with a pipe upsizing project completed at a repeat SSO site, Country Squire, which spilled on average 5 times a year from 2019 – 2021.

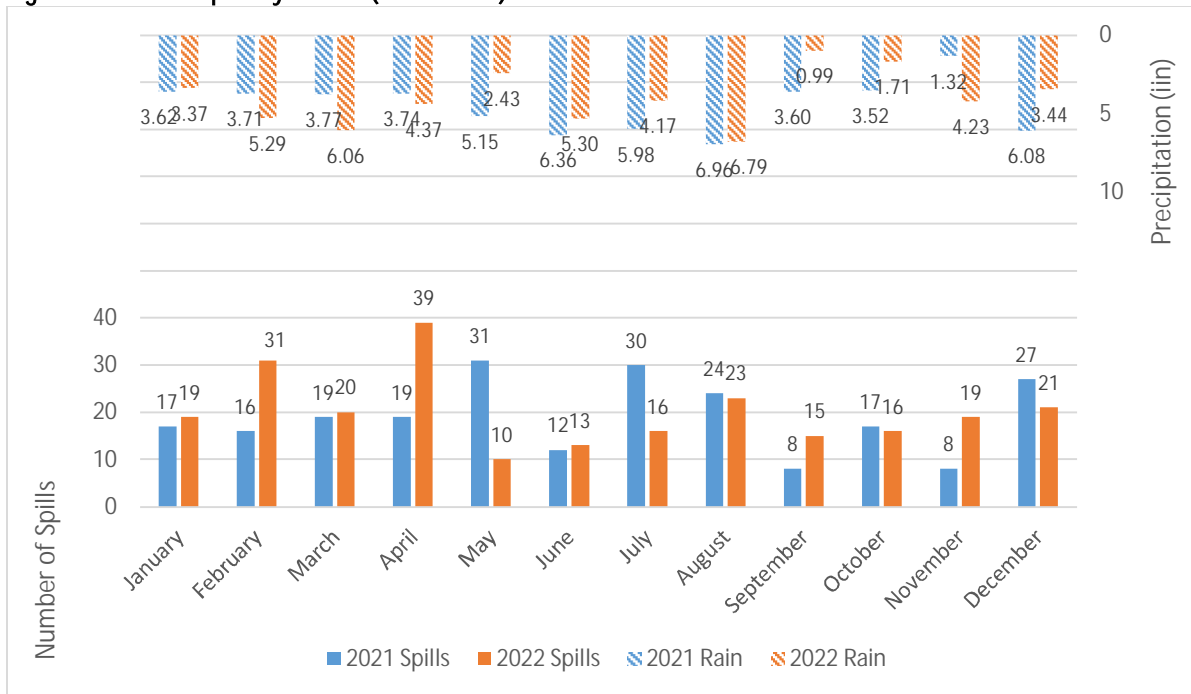
Figure 4-5 Spills by Month (2021–2022)

Overall, spills remained relatively constant from 2021 to 2022 due to similar number of significant rain events. Figure 4-5 shows a month-to-month comparison of spills from 2021 and 2022. In 2022, April saw the most spills due to a significant rain event on April 5 while February recorded the second highest number of spills for the year due to consistent, steady rainfall throughout the month.

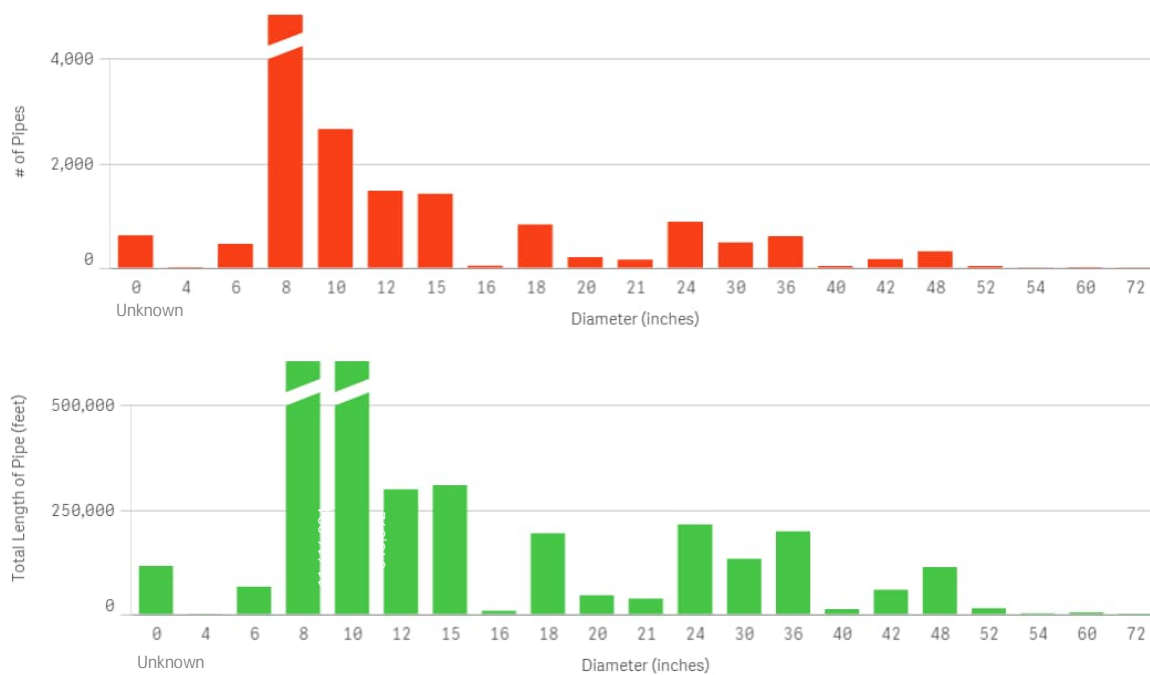
Figure 5-1 Sewer Gravity Main Pipe Count and Length by Diameter

The most common pipe diameter in the collection system is 8 inches, as shown on Figure 5-1. Pipes with a diameter of 8 inches account for 85 percent of the total number of pipes and 83 percent of the total length of pipe. Likewise, most spills are associated with pipes of 8 inches in diameter (Figure 5-2).

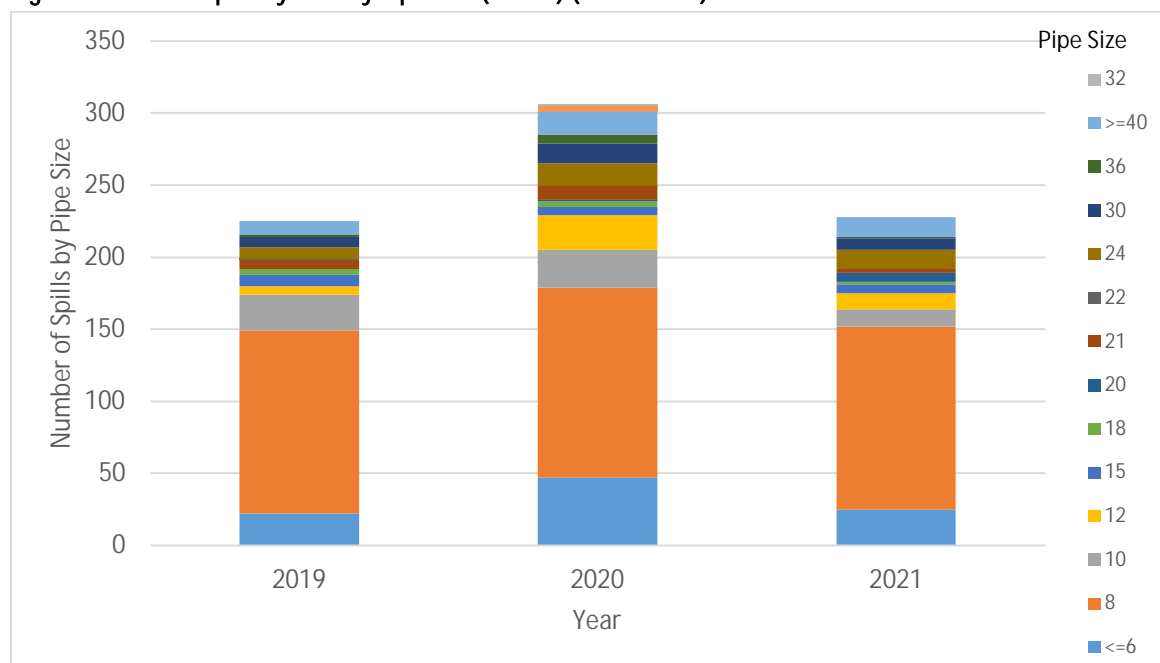
Figure 5-2 Spills by Year by Pipe Size (inches) (2020–2022)

Only spills have an associated pipe size linked to an SSO, so only spills are included in this figure.

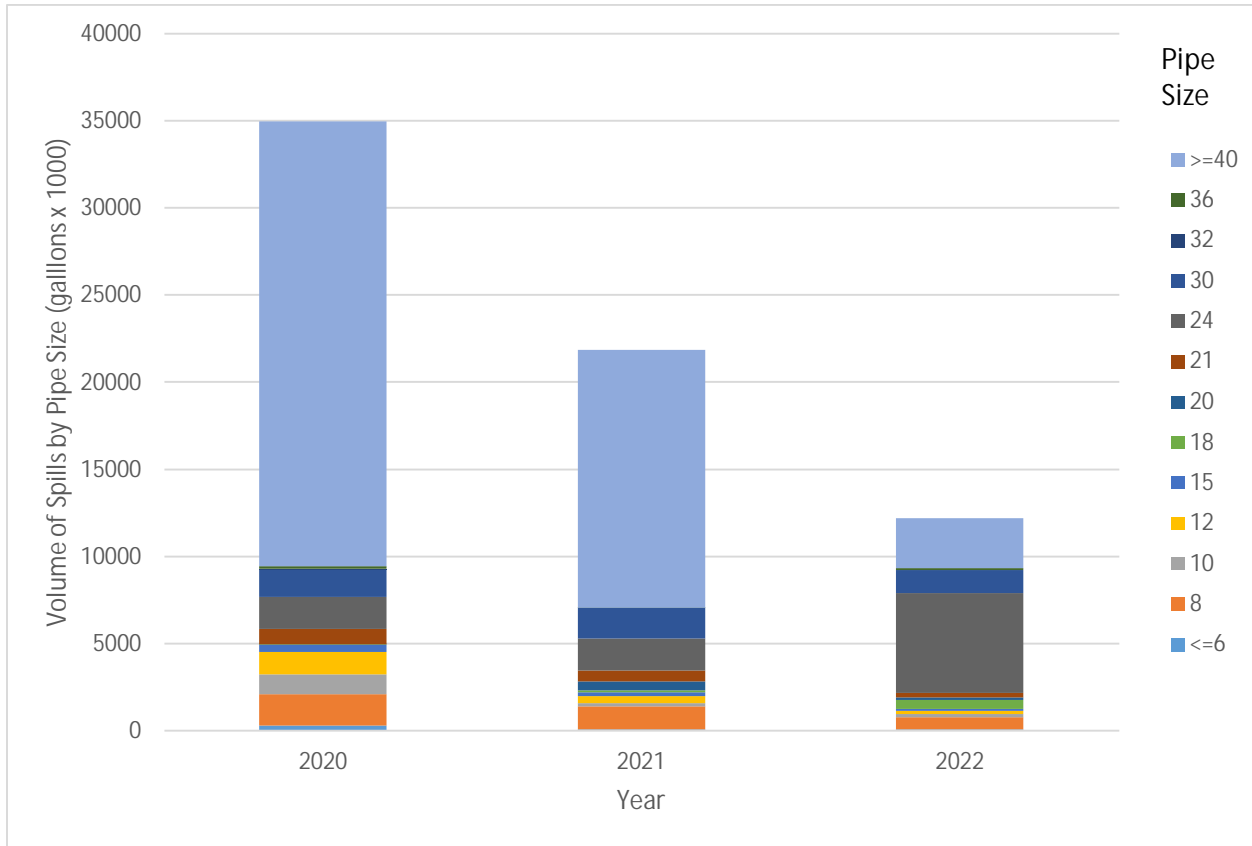
Figure 5-3 Spill Volume by Year by Pipe Size (2020–2022)

Figure 5-3 shows the volume of spills by pipe size. There is correlation between pipe size and volume of SSO, as larger pipes have greater capacity, generally convey more flow, and in cases of structural repairs, can take longer to restore.

Only spills have an associated pipe size linked to an SSO, so only spills are included in this figure. Pipe diameter was not always recorded; thus, some are blank or N/A.

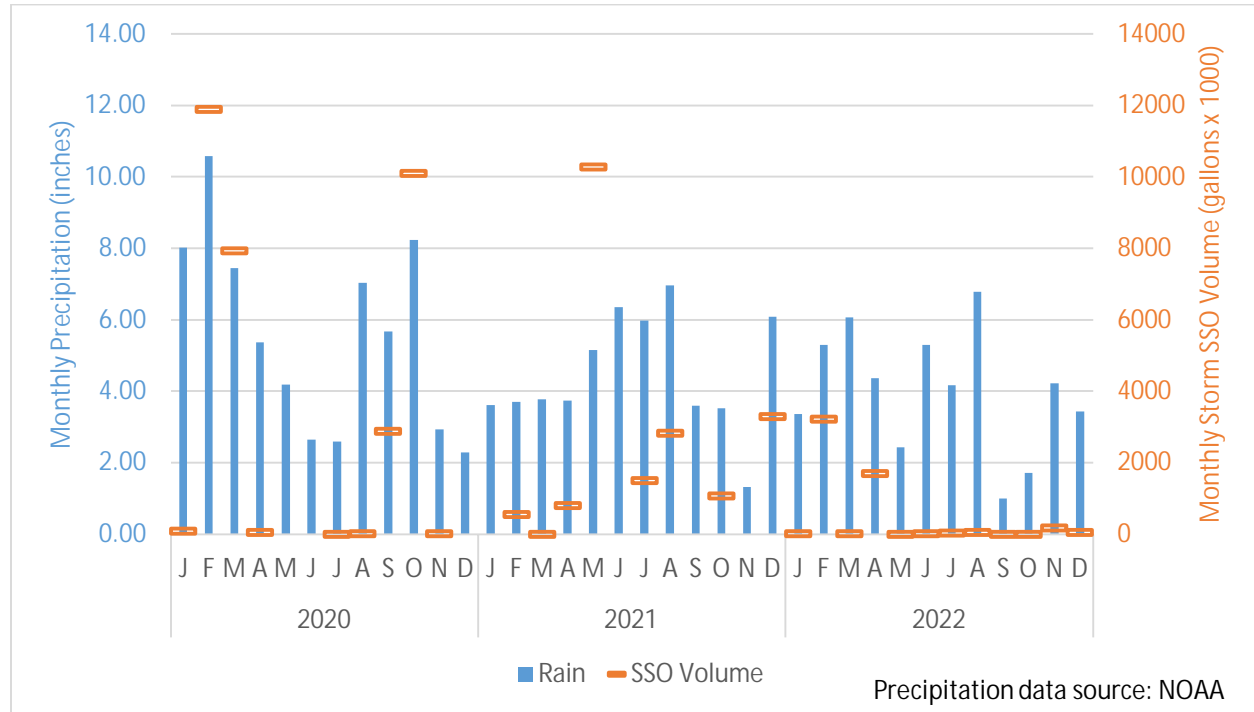
Figure 5-4 Monthly Precipitation and Wet-Weather-Induced SSO Volume (2020–2022)

The difference in rainfall intensity is reflected in the data for SSOs and spills caused by wet weather. In 2020, 145 spills were attributed to wet weather (101 occurred on 6 severe wet weather events that exceeded 2-year recurrence levels); in 2021, 74 spills were attributed to wet weather (47 occurred on 4 severe wet weather events that exceeded 2-year recurrence levels); and in 2022, 90 spills were attributed to wet weather (29 were attributed to Others). The volume for spills caused by wet weather was approximately 32.9 million gallons in 2020 (20.2 million gallons attributed to the six events noted previously) compared to an approximately 20.3 million gallons in 2021 (14.9 million gallons attributed to severe wet weather events that exceeded the 2-year recurrence level) and 5.3 million gallons in 2022. Figure 5-4 shows rainfall and SSO volume by month from 2020 through 2022.

Note: Only spills with a cause of STORM or I/I are represented on this figure.

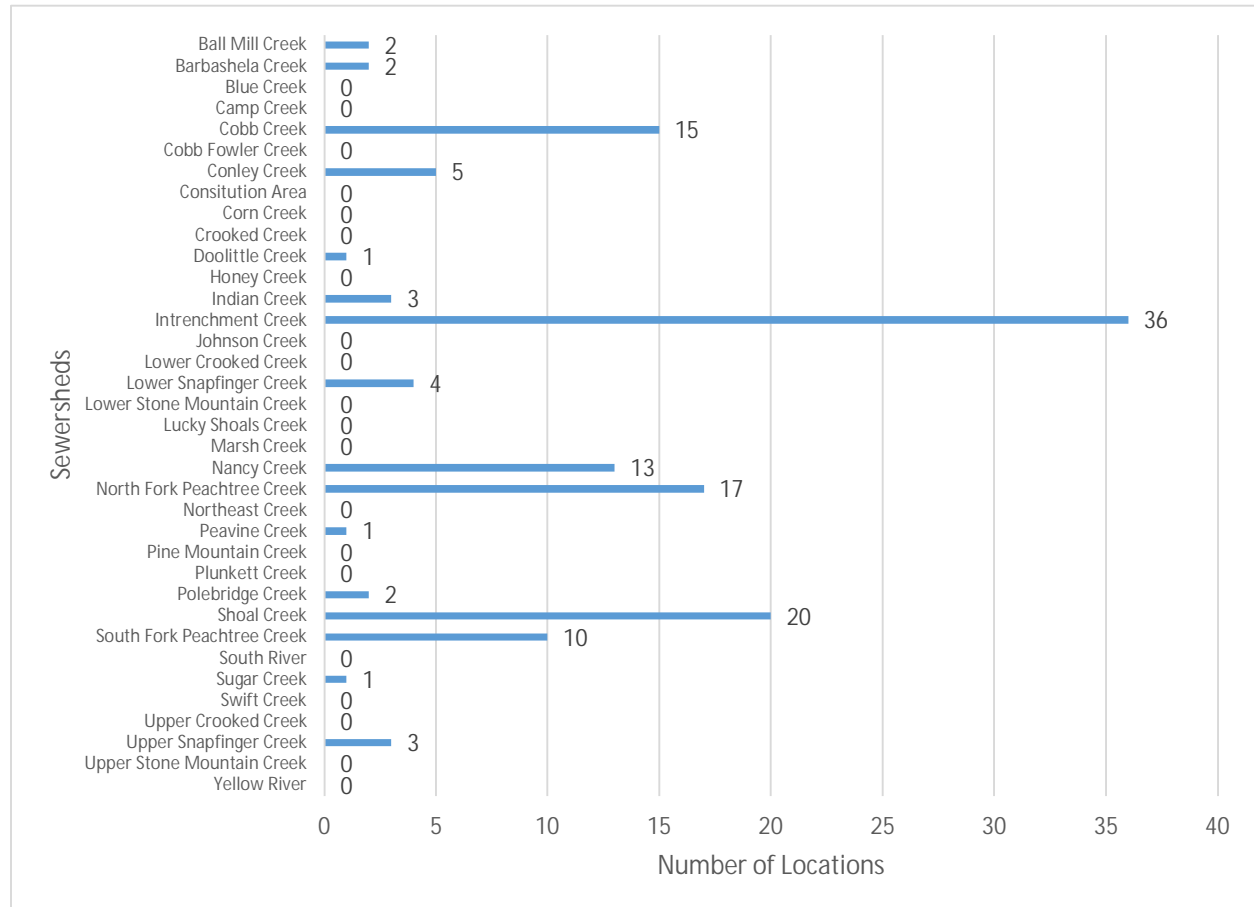
Figure 5-5 Number of Locations with Repeat SSOs by Sewershed

DWM defined 500-foot-radius areas with repeat SSOs and tallied the repeat SSO locations by sewershed (refer to Figure 5-5). For 2022, the total number of repeat SSOs was 135. Intrenchment Creek and Shoal Creek had the greatest number of repeat SSO locations.

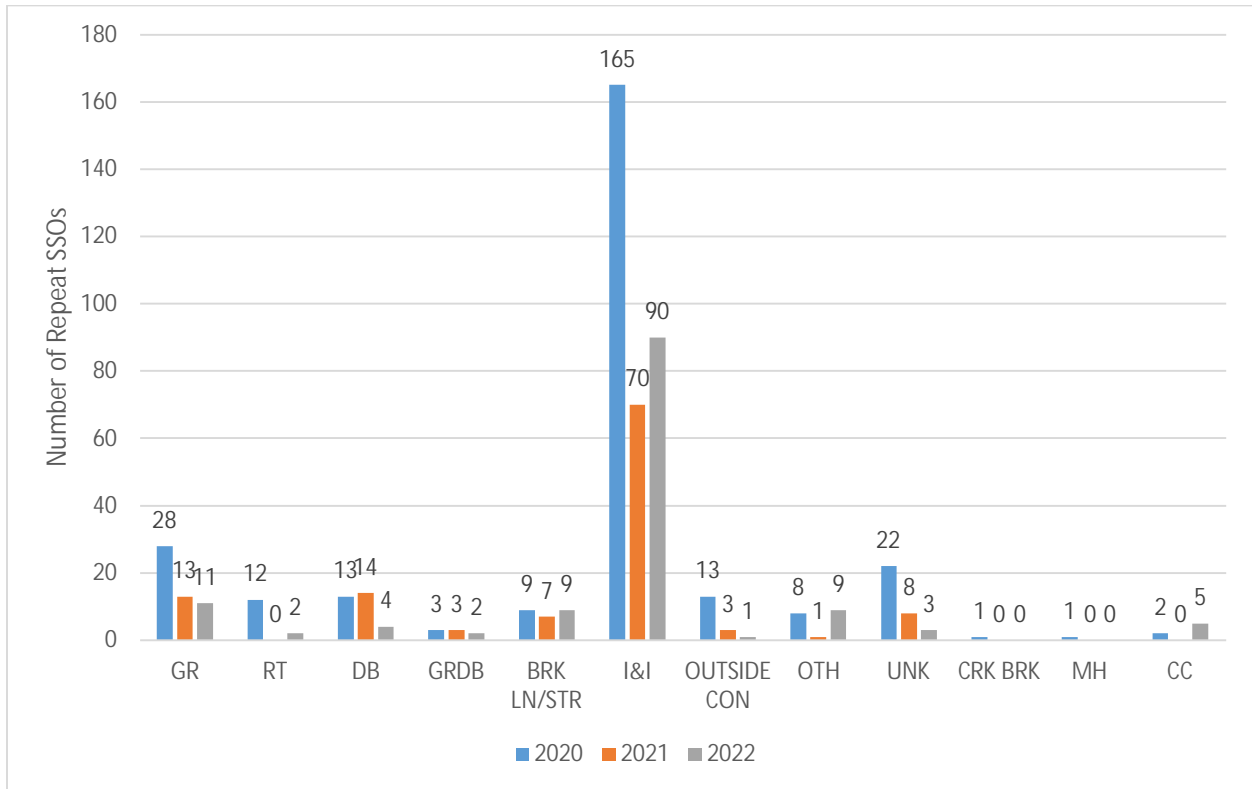
Figure 5-6 Number of Repeat SSOs by Cause (2020–2022)

The most common cause of repeat SSOs in 2022 was wet weather (refer to Figure 5-6). Wet-weather-related, repeat SSOs decreased from 2020 to 2021 due to overall less rainfall but show an increase from 2021 to 2022 due to an increase of SSOs by Others. As planned rehabilitation measures are constructed to reduce I/I sources and provide capacity in the system, wet-weather SSOs are expected to decrease. DWM has identified historical repeat SSOs and has developed remediation plans to address these issues.

Note: All I/I SSOs recorded to date were wet-weather-related.
