Annual Report No. 11

January 1, 2022, to December 31, 2022
Civil Action No. 1:10cv4039 - SDG

DeKalb County
Department of Watershed Management

March 1, 2023

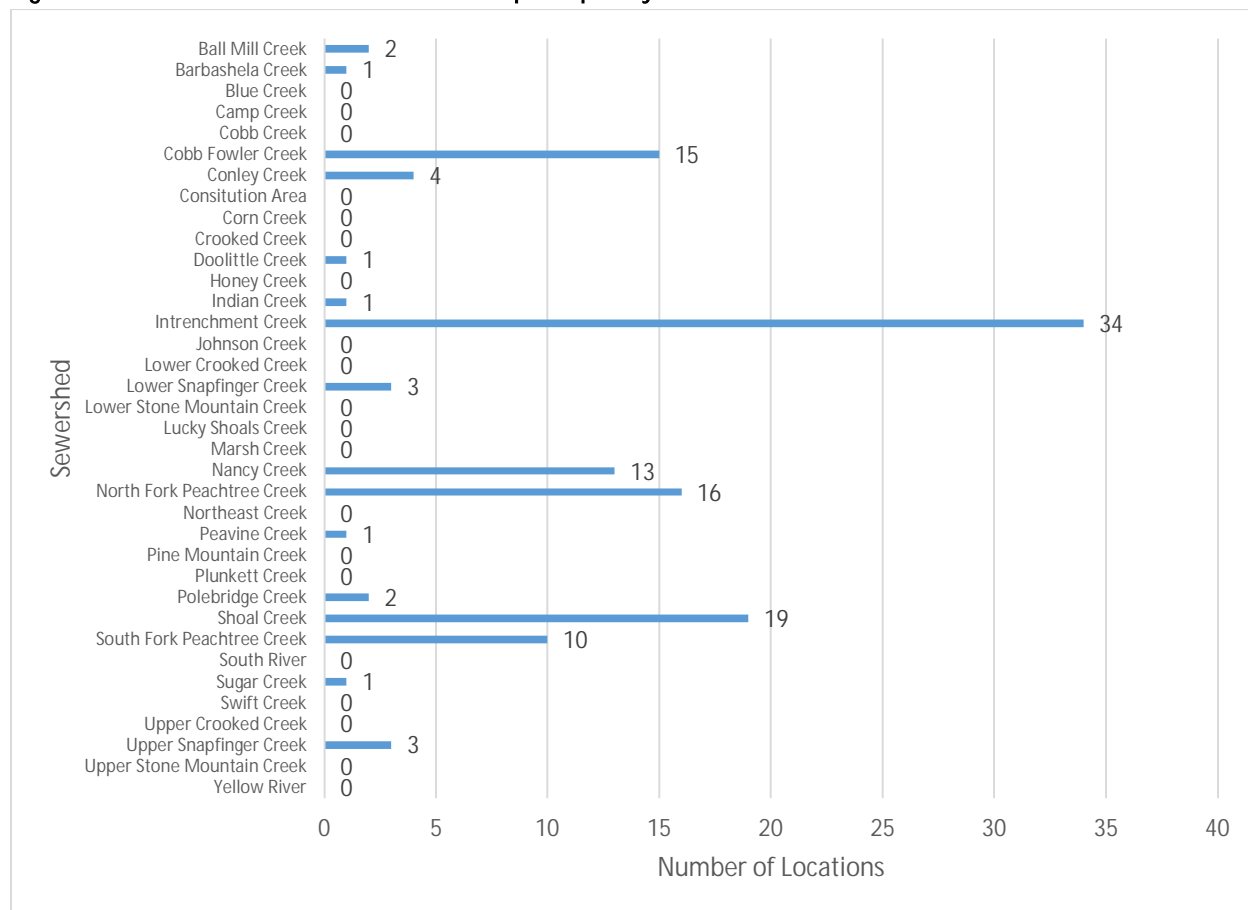
Figure 5-7 Number of Locations with Repeat Spills by Sewershed

Similarly, DWM analyzed only those SSOs that are categorized as spills. From 2021 to 2022, repeat spills increased, particularly in Intrenchment Creek where City of Atlanta trunks convey flow through the County. Intrenchment Creek, Cobb Fowler Creek, North Fork Peachtree Creek, and Shoal Creek had the greatest number of repeat spill locations in 2022 (refer to Figure 5-7).

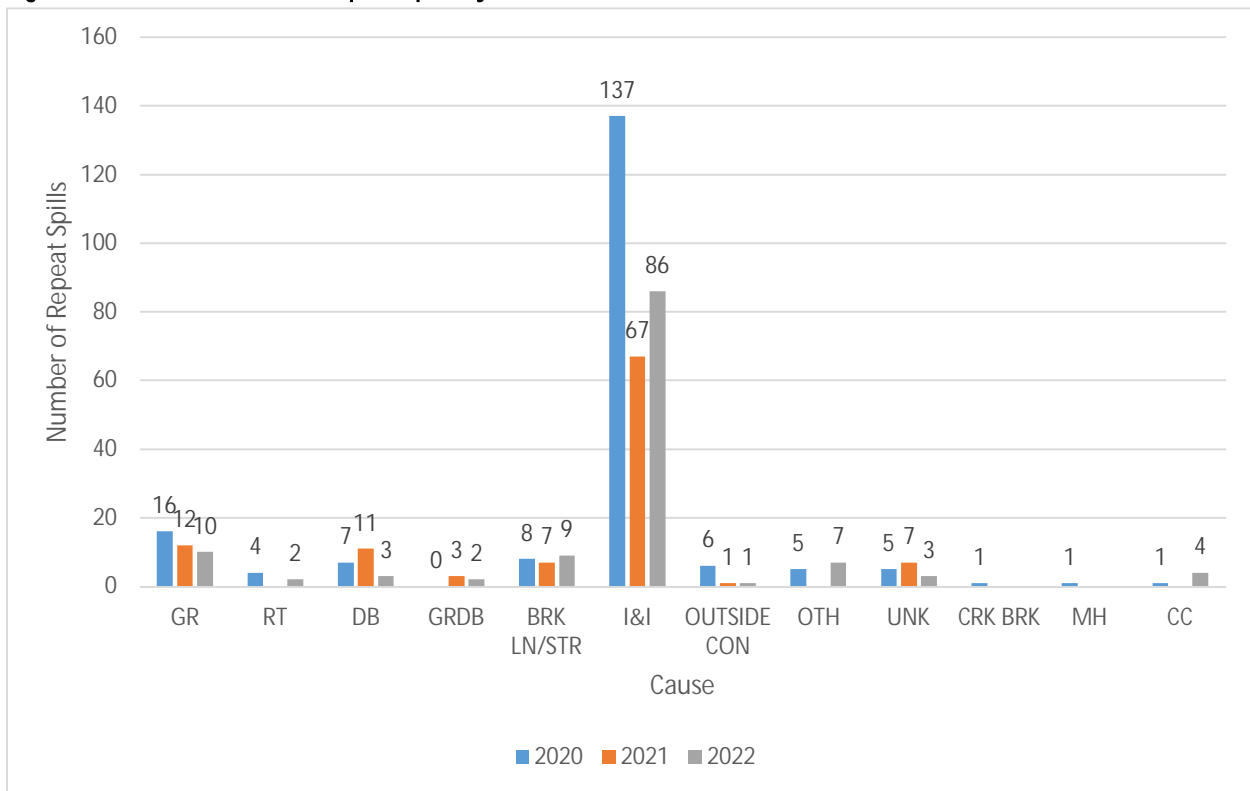
Figure 5-8 Number of Repeat Spills by Cause

The most common cause of repeat spills is wet weather (refer to Figure 5-8). Wet-weather-related repeat spills increased from 2021 to 2022, when taking into account spills by others. As rehabilitation measures are constructed to reduce I/I sources and provide capacity in the system, wet weather SSOs are expected to decrease.

Note: All I/I SSOs recorded to date were wet-weather-related.
